Subject: Final Phase III Bond Release, Canyon Fuel Company, LLC, Gordon Creek 2, 7 & 8 Mine, C/007/0016, Task #6001

Phase III Bond Release
Remaining 34.15 Acres
Canyon Fuel Company, LLC
Gordon Creek 2, 7 & 8 Mine
C/007/0016
Carbon County, Utah

Inspection Report

Permit Number:	C0070016
Inspection Type:	BOND RELEASE
Inspection Date:	Thursday, October 31, 2019
Start Date/Time:	10/31/2019 10:00:00 AM
End Date/Time:	10/31/2019 12:00:00 PM
Last Inspection:	Wednesday, July 31, 2019

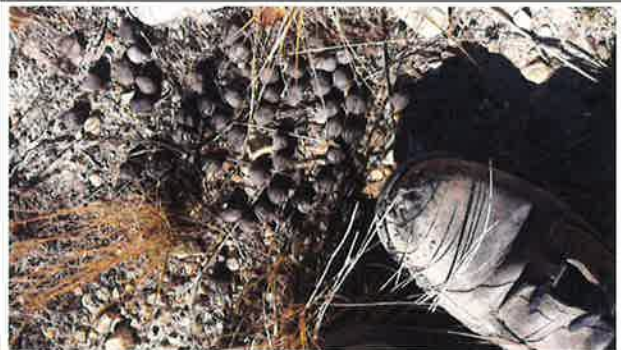
ELK SIGN

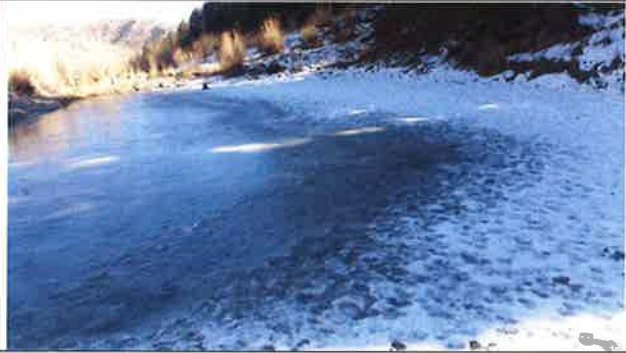
The reclaimed mine site contains one small pond that is remaining in place. Designated as "Jacob's Pond" a depression acts as a small stock watering pond and is fed by an adjacent natural seep. Jacob's Pond appeared to be in good condition and the water was frozen over during the inspection.

FROZEN JACOB'S POND		SEEP ABOVE JACOB'S POND	
October 24, 2019		October 24, 2019

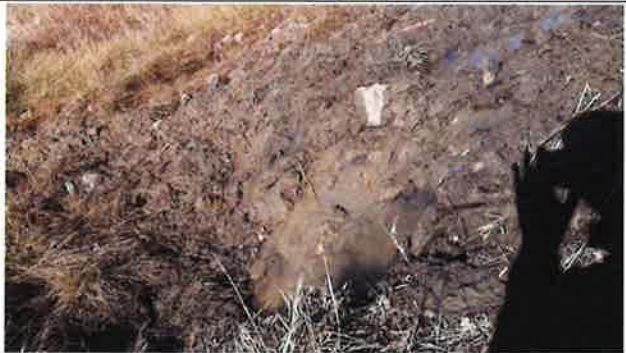
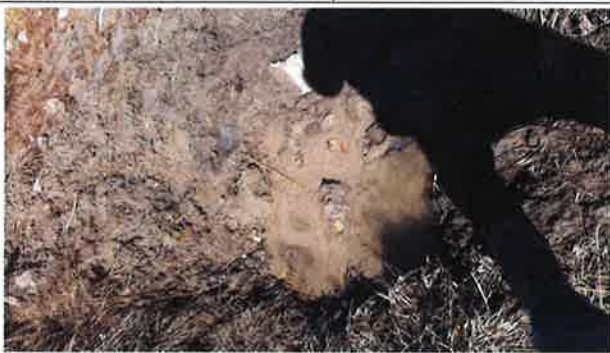
A small section above Jacob's Pond appears to be saturated by a seep that continually flows from the steeper part of the slope overlooking the pond. The water that flows from the seep flows toward Jacob's Pond, and has periodically saturated sections of the hillside along the way. It appears that the slopes have remained stable due to the abundance of grasses and other vegetation that have taken hold in this area.

SEEP ABOVE JACOB'S POND		SEEP ABOVE JACOB'S POND	
October 24, 2019		October 24, 2019

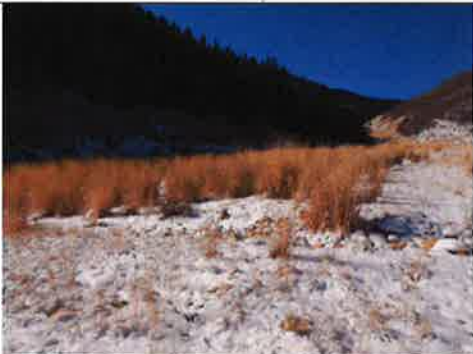
SEEP ABOVE JACOB'S POND		PHOTO 28	
October 24, 2019		October 31, 2019
